# **DAMAGE MITIGATION STRATEGIES**

# **NON-STRUCTURAL INFILL WALLS**

A thesis submitted in partial fulfilment of the  
requirements for the Degree of  
Doctor of Philosophy in Civil Engineering  
by

Department of Civil and Natural Resources Engineering  
University of Canterbury  
Christchurch, New Zealand

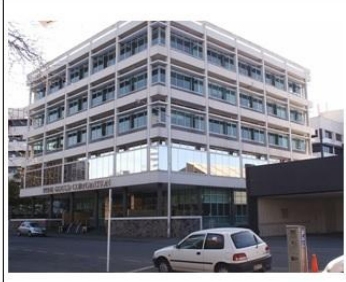
<b>(22) CAMBRIDGE 233</b>		
Number of Storeys	5

Structure Type	R/C Frame	
Infill Type	Unknown	
Configuration	Vertical Irregularity	
Function	Office	
Possible Deficiencies	Soft Storey	
Observed Damage After 2010 Darfield Earthquake	-

**Figure 1.4.** The observations for the PGC building after 4<sup>th</sup> September 2010 Darfield earthquake (Photo by Tasligedik, A.S.)

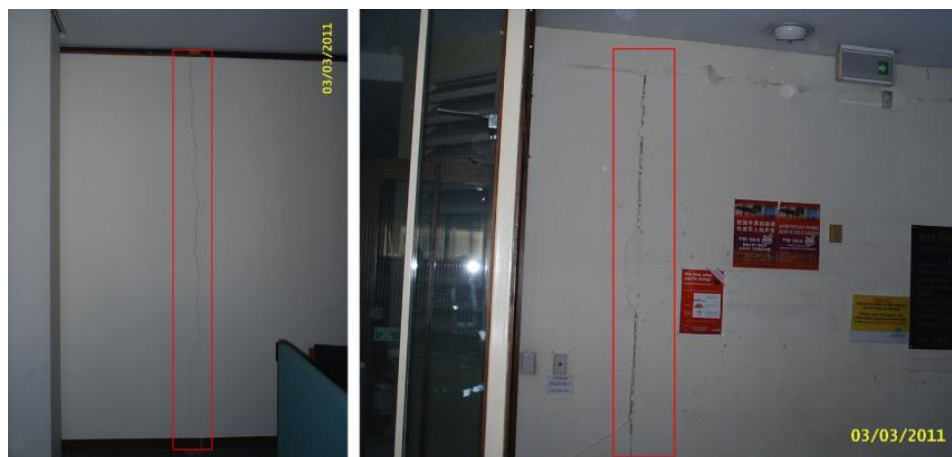
**Figure 2.7.** Damage observation after 22<sup>nd</sup> February 2011 Christchurch earthquake: Interface cracking among adjacent linings

After the 22<sup>nd</sup> February 2011 Christchurch earthquake, significant damage to drywall partitions was observed in almost all of the buildings. In order to give an overview of the observed damage, the photographic records are reported in this section. The most common damage was cracking at interfaces among adjacent linings. Almost all of the buildings had drywall partitions cracking in this manner at a certain level. In addition, cracking at lining corners caused by tightly finished corners is another common damage observed (e.g. around the corners of windows or doors). In some cases, the linings detached from the underlying framing due to significant diagonal compression imposed on the linings, resulting in breaking at lining corners.

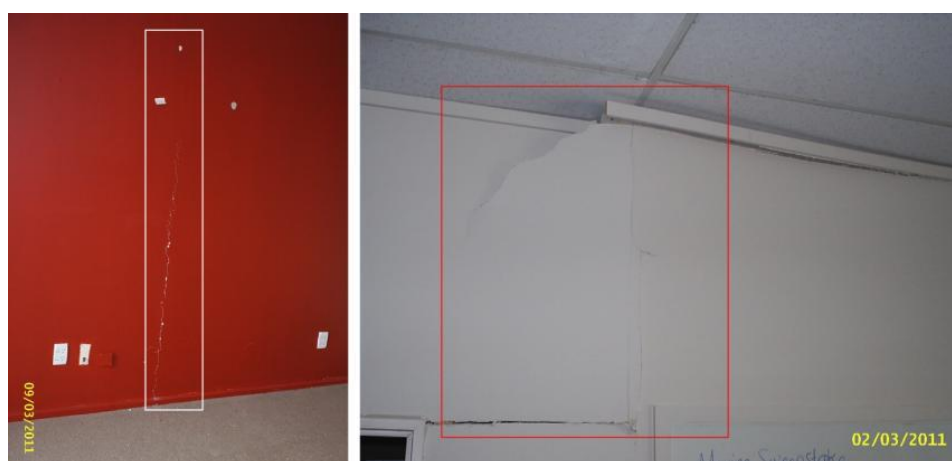
**Figure 2.8.** Damage observation after 22<sup>nd</sup> February 2011 Christchurch earthquake: a) Interface cracking among adjacent linings, b) Broken gypsum lining

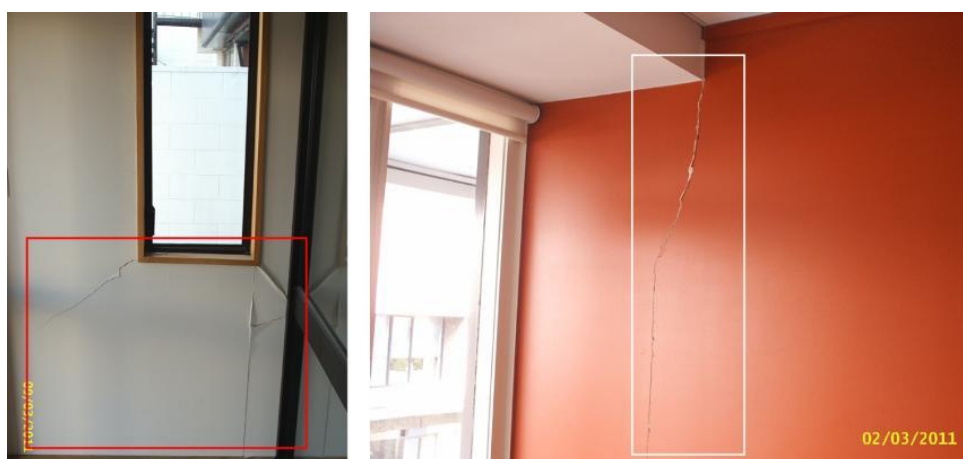
**Figure 2.11.** Damage observation after 22nd February 2011 Christchurch earthquake: a) Lining cracking due to tightly fixed window corner, b) Lining cracking due to tightly fixed beam corner

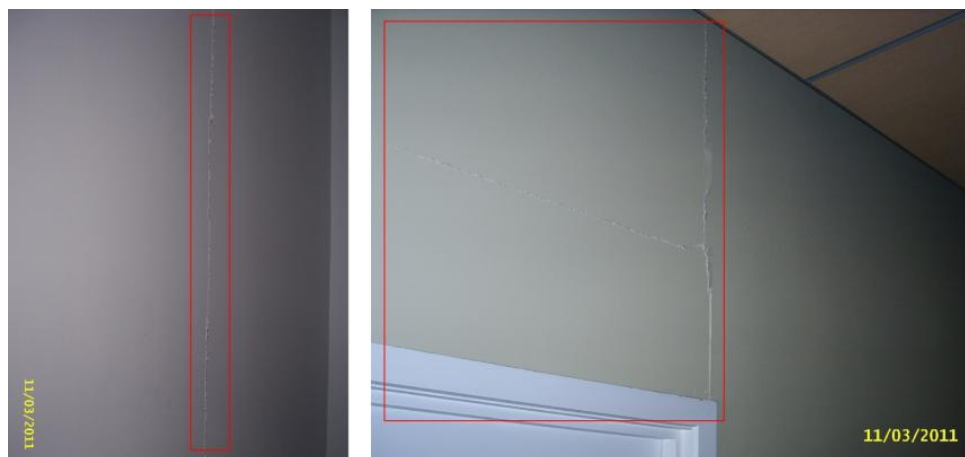
**Figure 2.13.** Damage observation after 22nd February 2011 Christchurch earthquake: Interface cracking among adjacent linings

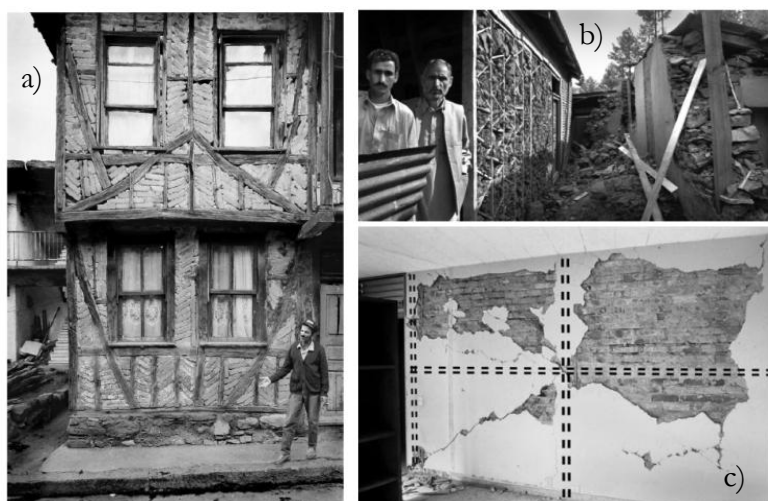
**Figure 3.1.** a) Armature cross-wall structure at the epicentre after Duzce 1999 earthquake in Turkey (no damage), b) Armature cross wall structure in Pakistan (the damage to the adjacent URM building is severe compared to the armature cross-wall, c) Armature cross-wall applied in practice to an RC structure in 1965. The building suffered soft storey at ground level after 1965 San Salvador earthquake. However, progressive pancake was prevented due to the infill wall's being intact with the sub-framing.

Langenbach [37] considered old armature cross wall practices, typical in regions like Turkey, India and Pakistan, and their performances after seismic events. The author proposed modernized methods based on observations made after major earthquakes and expressed the importance of learning from past construction practices, which are considered to be obsolete. The considered ancient practice of armature cross wall is shown in Figure 3.1 along with an adapted version to a comparably modern building. According to the International Building Code [38], a cross-wall is defined as an interior partition wall that is not a shear wall but nonetheless provides structural support and hysteretic damping. The term “armature” refers to use of a “sub-frame” to subdivide the masonry walls. Armature cross-walls are thus infill masonry walls modified by the introduction of a sub-frame of studs and cross pieces and the deliberate use of a weak lime-based mortar. These studs and cross pieces would be securely attached to the RC frame, with bricks tightly packed in between. By generating less initial stiffness than standard infill masonry walls, multi-story frame can behave as a bare frame rather than an infilled RC frame. Therefore, cross-walls

reduce the problems and complexities caused by the frame infill interaction, which could lead to undesired local or global failure mechanisms as shear failure in columns or a soft storey mechanism. Moreover, the studs and cross pieces prevent the formation of an equivalent diagonal strut, while substantially increasing the out-of-plane resistance. The author also stated that weaker timber studs and crosses in the old types of armature cross walls did not get any damage after earthquakes and this can be attributed to subdivision of the infill panel into smaller panels using studs and horizontal members and a low strength mortar, which reduces the initial stiffness and prevent the formation of diagonal cracking due to prevention of equivalent diagonal strut formation. In addition, these modifications change the global behaviour of the structure to a more ductile one, which was stated by the author to be the cause of the desirable behaviour observed in these old structures.

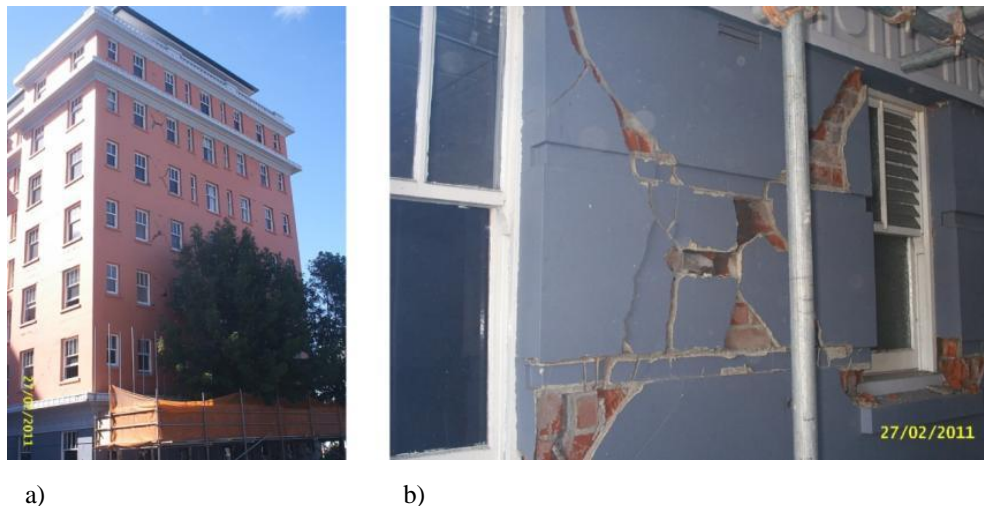
**Figure 3.11.** Observed damage on masonry infills after the 22<sup>nd</sup> February 2011 Christchurch earthquake: a) Diagonal cracking, b) Close up view of the diagonal cracking

Although heavy masonry infill walls are not the most popular cladding type currently, there was a large number of building stock suffering damage to their heavy masonry infills after Christchurch earthquake in 22<sup>nd</sup> February 2011. The most common masonry infill type for old buildings was unreinforced clay brick infills. For newer buildings, reinforced grouted hollow masonry infill walls were the most common type. However, these two types of infill walls have very similar damage and failure mechanisms. The damage to these masonry infill walls is photographically summarized in this section.

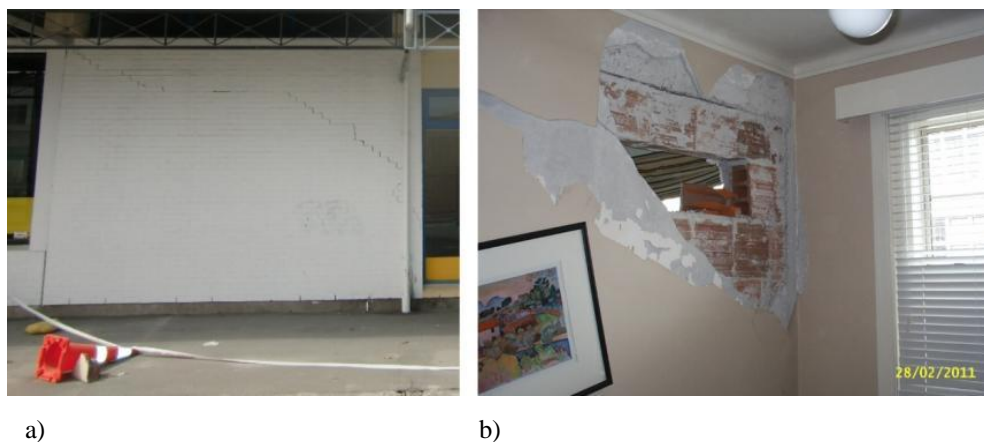
**Figure 3.12.** Observed damage on masonry infills after the 22nd February 2011 Christchurch earthquake: a) Sliding shear crack, b) Overall corner damage

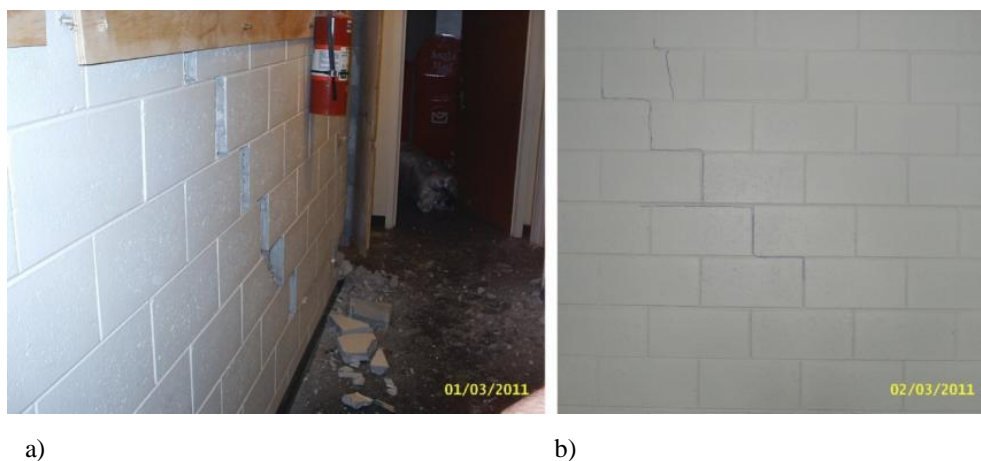
**Figure 3.17.** Observed damage on masonry infills after the 22nd February 2011 Christchurch earthquake: a-b) Diagonal crack

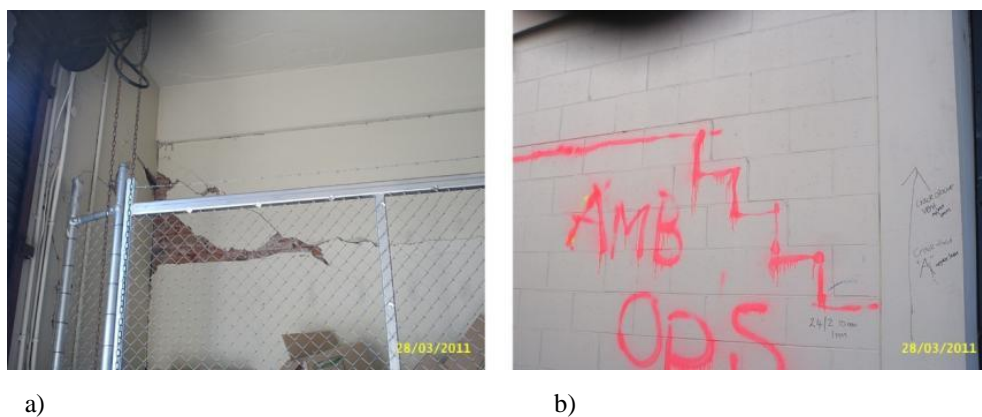
**Figure 3.20.** Observed damage on masonry infills after the 22nd February 2011 Christchurch earthquake: a-b) Sliding shear crack

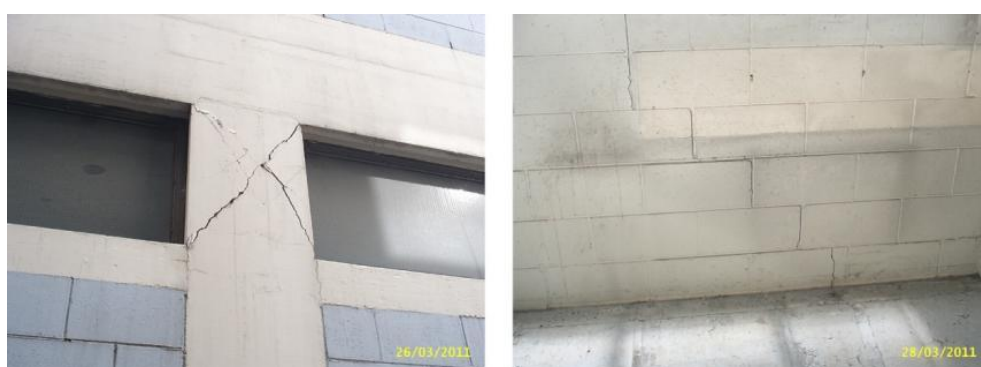
**Figure 3.24.** Observed damage on masonry infills after the 22nd February 2011 Christchurch earthquake: a) Short column, b) Diagonal cracking

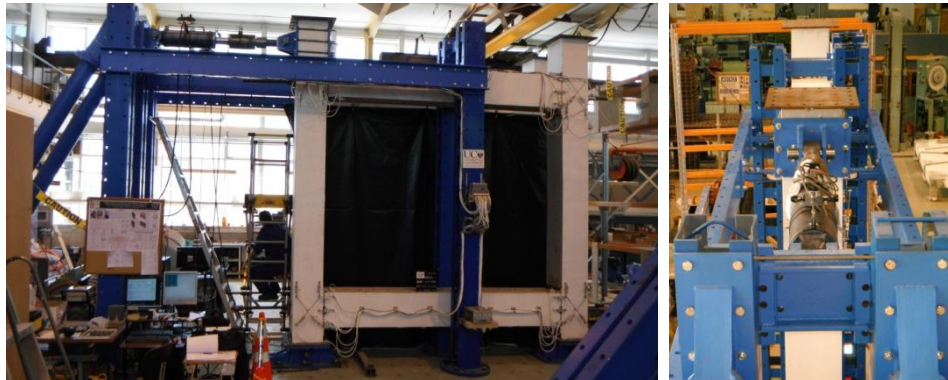
The construction was carried out in four steps. In the first step, the pin supports were fixed to their positions and locked in place so that the rotation at pins was constrained. Then, two external steel columns were placed next to the pin supports, to which the reinforced concrete columns were secured for additional safety. In the second step, the lower reinforced concrete beam was placed onto the steel corbels provided on columns. In the third step, the upper beam was placed onto the upper steel corbels on the columns. This was followed by placing post tensioning bars at both beams with a small amount of post tensioning to hold the system together. In the fourth step, the two external steel columns were removed and the second out-of-plane steel column at the middle part of the specimen was installed and another steel beam was fixed between the reaction frame and this column. Lastly, the rollers were placed at the upper beam level in order to prevent out-of-plane deformation of the specimen. The details of the used rollers and pin supports are shown in Figure 4.15.

**Figure 4.14.** Construction sequence of the bare frame and completed view (For out-of-plane rollers and pin support details, refer to Figure 4.15)

The bare frame (BF) is the structural part of the test setup and it was repeatedly used by only changing the infill panel content. In order to determine its reverse cyclic behaviour, the bare frame was tested as the first test specimen. The construction sequence of the bare frame is summarized in Figure 4.14.

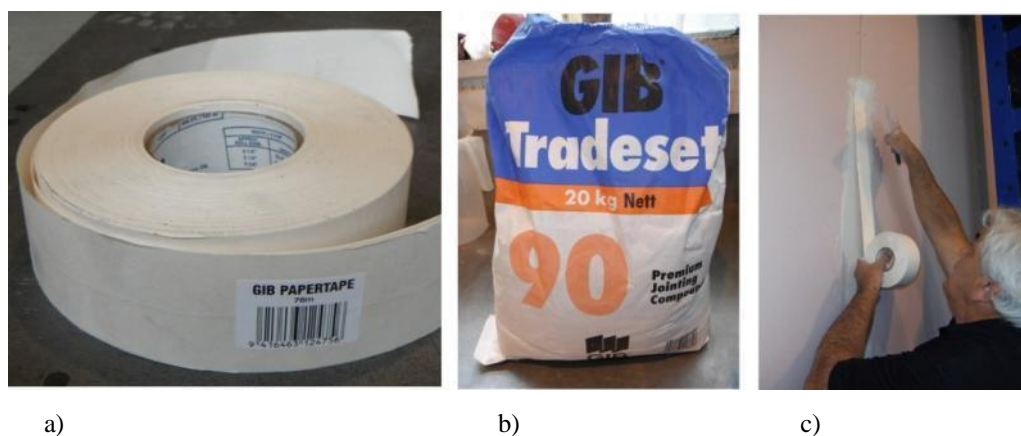
For drywalls, the preferred method of finish is a flushed wall surface and square stops at wall ends. The finishing was done by applying the plaster at any of the desired lining-to-lining or lining-to-concrete interfaces. Then the paper tape was applied on the plaster using another thin layer of the plaster on the tape. The porous structure of the paper tape allows for the penetration of the plaster and provides a tight fixing to the lining. The used materials and the installation procedure are shown in Figure 5.4. After this phase, the specimens were painted using a thin coat of white paint to allow for ease of visibility for damage and crack marking.

**Figure 5.4.** Standard finishing for drywalls: a) Paper tape, b) Plaster, c) Application

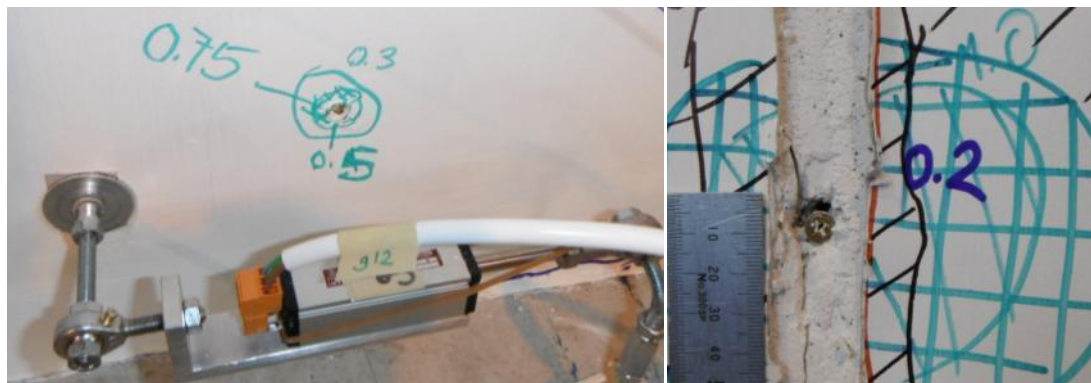
**Figure 6.1.** Damage at the fasteners observed at as built steel framed drywall FIF1-STFD

After studying the behaviour of the as built drywall practice, it was observed that the horizontal displacement demand imposed at the lower and upper boundaries of the infill panel zone was significantly high as shown by the related potentiometer readings in the previous chapter. The fasteners used to fix the gypsum linings to the steel framing started to loosen even from the initial cycles, damaging the gypsum lining (Figure 6.1). Also, the screws used to fix the steel studs to the steel tracks remained in place, but they caused stud rotation as drift amplitudes were increased. This further imposed damage to lining-to-lining interfaces since the vertical steel studs were free to rotate about these screws.

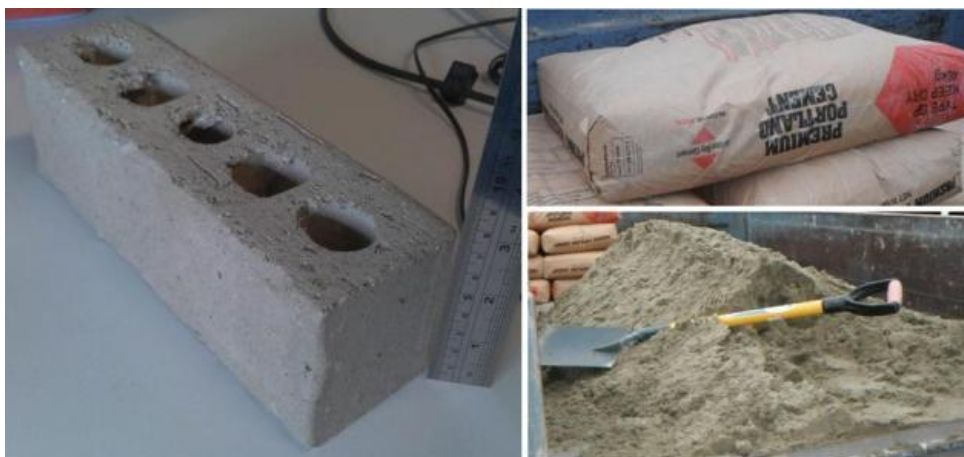
**Figure 7.2.** Used clay brick type (70×75×220 mm), Portland cement and fine sand

In the construction of the infill wall, standard clay bricks of 70 mm width, 75 mm height and 220 mm length were used. This was the same clay brick type used in St. Elmo Courts as well as for the construction of the masonry veneers in most of the residential houses in New Zealand (Figure 7.2).

The binding mortar was composed of Portland cement and fine sand mixed 1 to 4 weight ratios accordingly (Figure 7.2). The water content was arranged according to the workability of the mix by the contractor. In the construction of the infill wall, no specification was given to the contractor with the intent to respect the real life construction practice for brick work as much as possible.

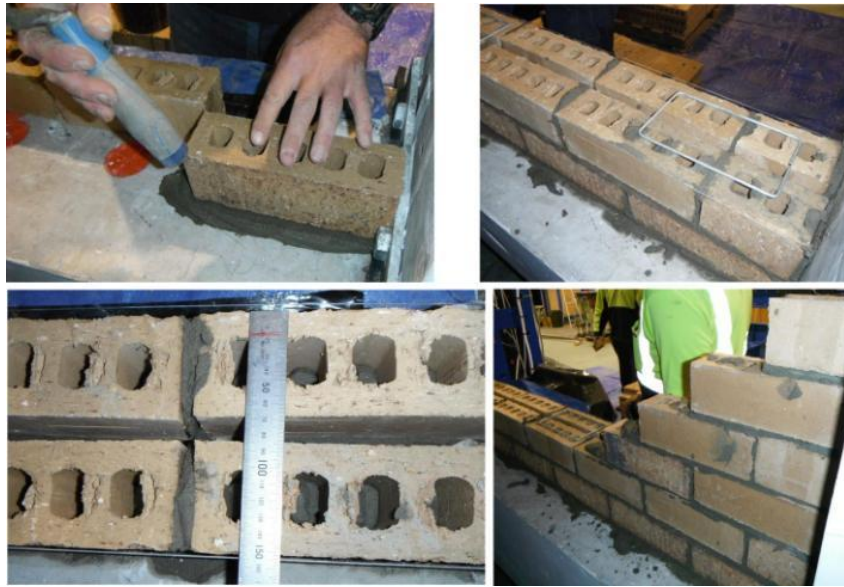
**Figure 7.3.** The construction of the double skinned unreinforced clay brick infill wall, as built unreinforced clay brick infill wall FIF3-UCBI

The bricks were laid from the lower corners of the infill panel zone to meet at the mid-span of the RC beam, i.e. four courses at a time. Steel ties were placed between the two skins of the wall at every fourth course of clay bricks laid in vertical. The steel ties were placed 600 mm apart from each other horizontally. The average thickness of the mortar layers was about 10 mm. Including the 10 mm cavity in between the two skins, the total thickness of the infill wall was 150 mm (Figure 7.3).

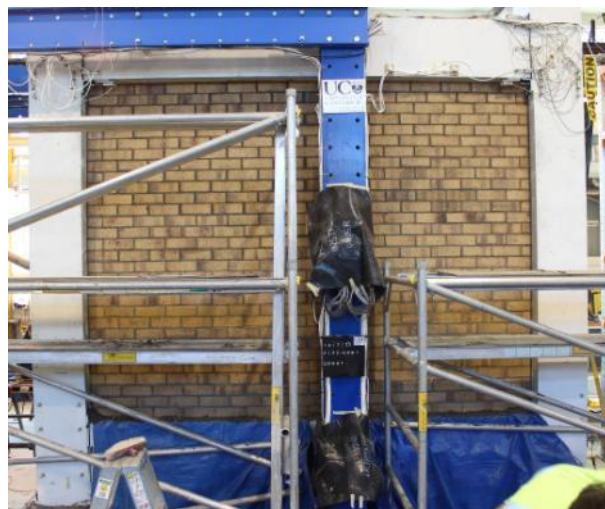
**Figure 7.4.** Completed unreinforced clay brick infill wall before the white paint was applied FIF3-UCBI

For finishing, only a thin coat of white paint was applied on the wall for ease of crack visibility. As in overseas practice, a mortar based plaster layer could be made both inside and outside of the wall. Since this could affect the results of the tests, this option was not chosen. Moreover, in New Zealand, these types of walls were usually built without any external plaster in the past due to its architectural appeal. The completed state of the infill wall is shown in Figure 7.4.

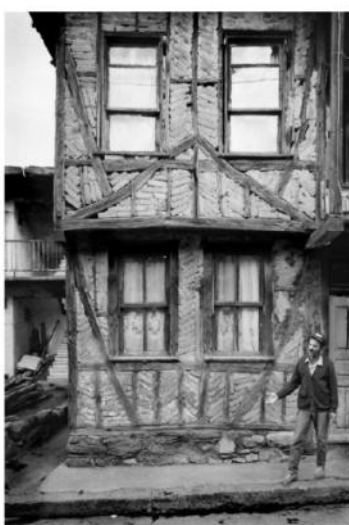
**Figure 8.2.** Armature cross walled structure at epicentre after the Duzce 1999 earthquake in Turkey from Langenbach [37]

As per the development of innovative low damage solutions for clay brick infills, only very few researches are available in literature [19, 20] and [21], as summarized previously in Chapter 3. The solution developed herein was typically and fundamentally inspired from the old construction practice of armature cross walls and recent rocking structural systems [46, 61]. As summarized by Langenbach [37], sub-framing masonry walls was a very old practice of construction especially in old structures in Turkey. After 1999 Duzce earthquake in Turkey, there were houses of this type without significant damage (Figure 8.2).

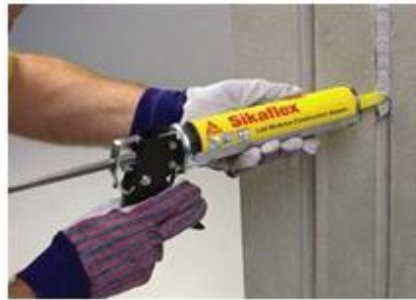
**Figure 8.9.** Polyurethane joint sealant application (Fire rated Sikaflex construction AP)

fire rated polyurethane joint sealant, fire rated Sikaflex construction AP (Figure 8.9). The resulting details are shown in Figure 8.8.

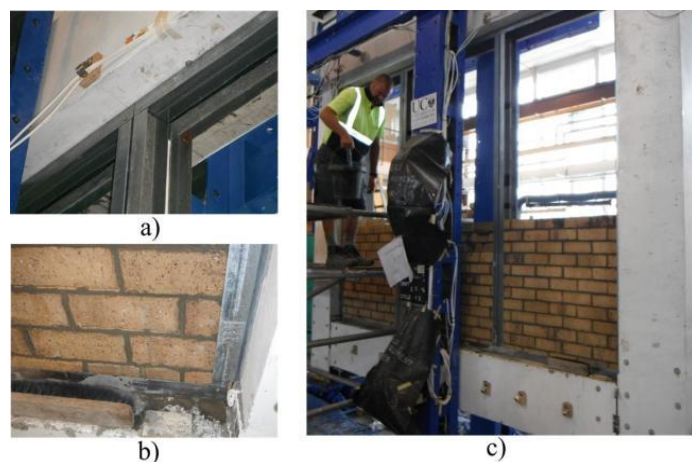
**Figure 8.11.** Low damage unreinforced clay brick infill wall specimen MIF5-UCBI: a) Connection of stud to the top track, b) The lower right corner of the infill panel zone after the construction started, c) General view during the construction

Once the joint sealant set within two weeks' time, the infill wall was completely integrated with the structural frame due to these flexible joints. The Phillips-head self drilling screws were then removed from the sub-frame, adding sliding capability to the infill wall. The photos from the various stages during the construction are shown in Figure 8.11 and Figure 8.12. The finishing was carried out in the same way as the as built specimen with a thin coat of white paint to allow for crack visibility.

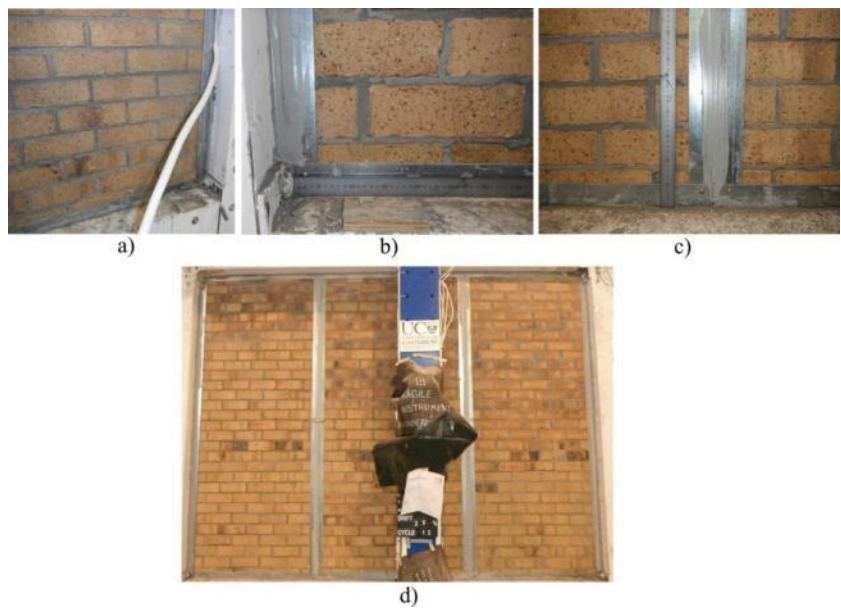
**Figure 8.12.** Low damage unreinforced clay brick infill wall specimen MIF5-UCBI: a) Polyethylene foam installation, b-c) External and internal joints after the polyurethane joint sealant application, d) General view after the construction was finished

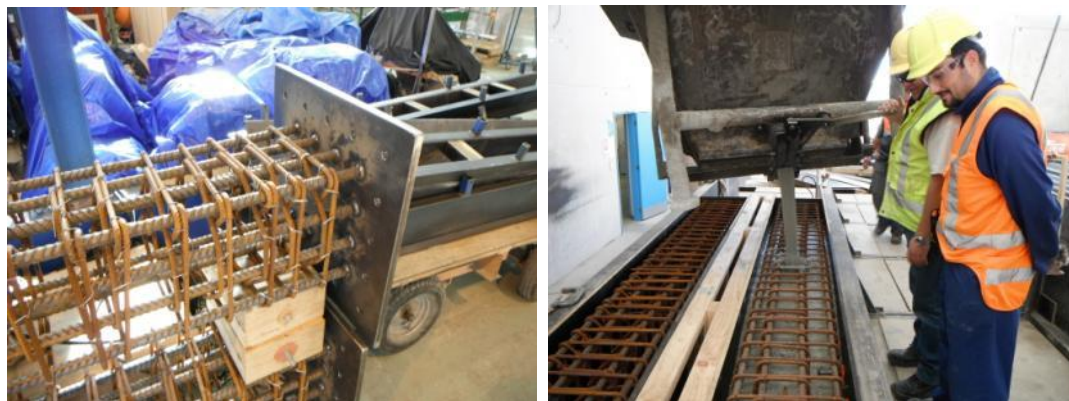
**Figure 0.1.** a) Reinforcing cage, b) Casting

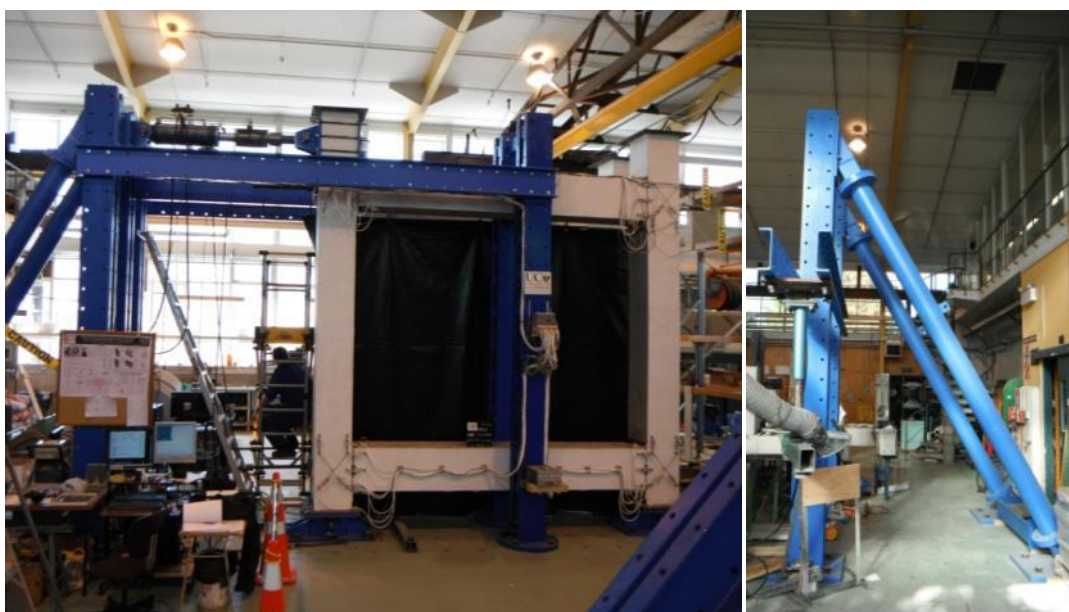
**Figure 0.2.** a) Bare frame specimen BF, b) The reaction frame

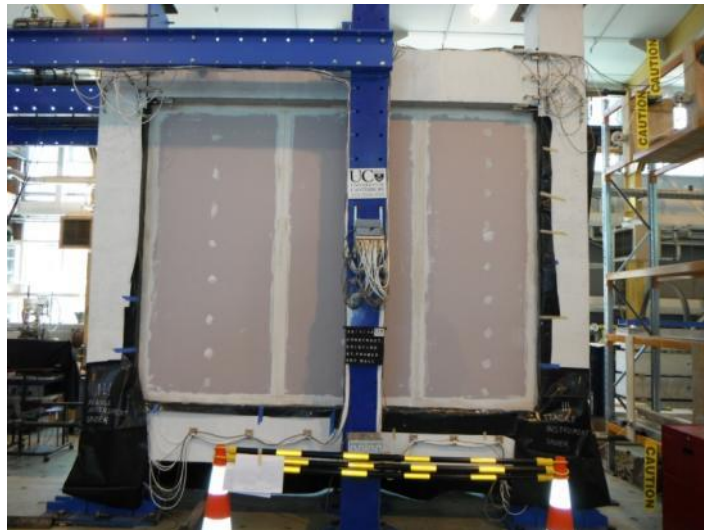
**Figure 0.8.** As built steel framed drywall specimen FIF1-STFD after the finishing

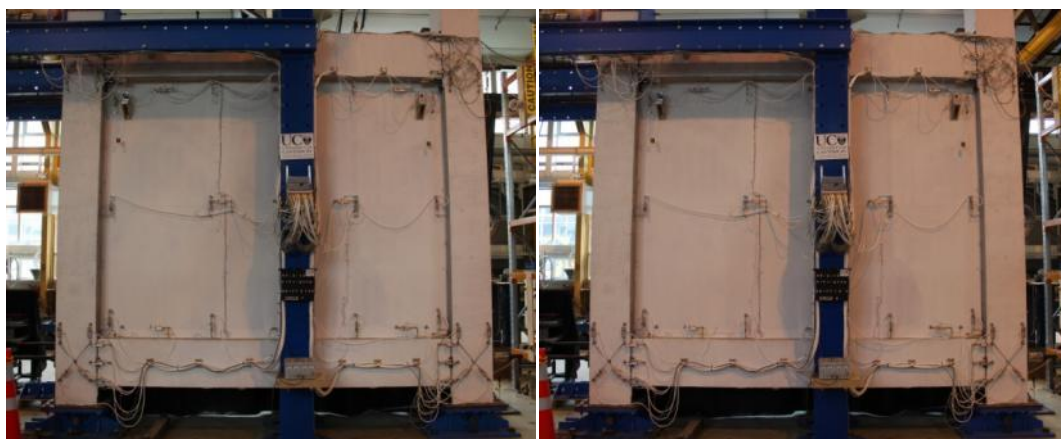
**Figure 0.11.** As built steel framed drywall specimen FIF1-STFD: a) 0.5% drift, b) 0.75% drift

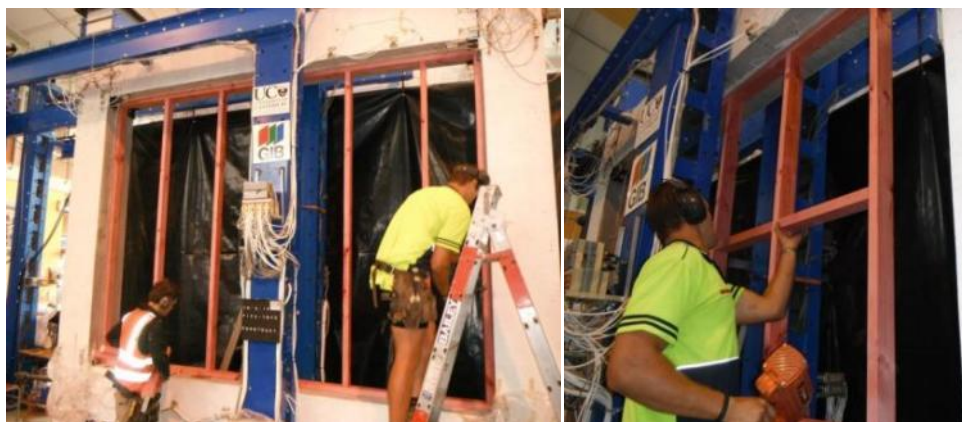
**Figure 0.15.** As built timber framed drywall specimen FIF2-TBFD: Installation of the timber elements

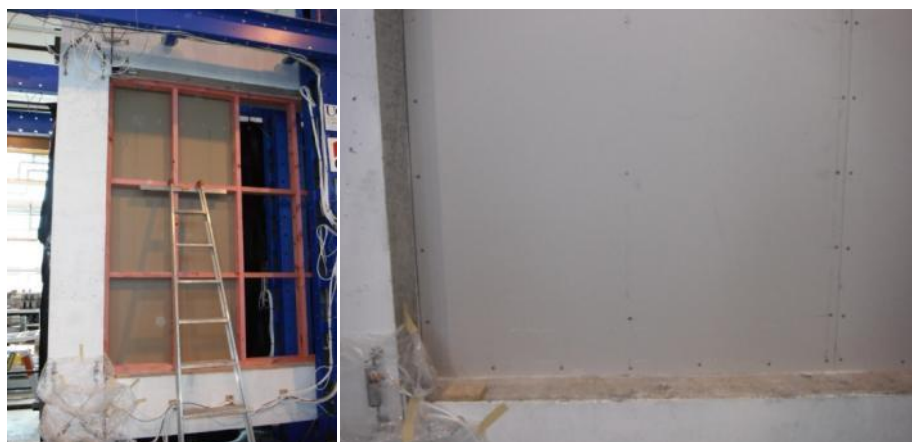
**Figure 0.17.** As built timber framed drywall specimen FIF2-TBFD, Installation of the gypsum linings

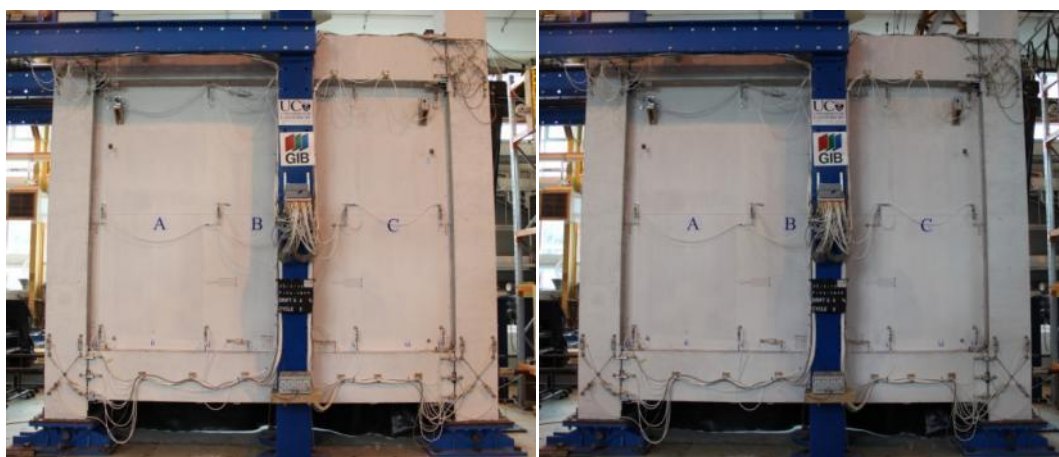
**Figure 0.19.** As built timber framed drywall specimen FIF2-TBFD: a) 0.3% drift, b) 0.4% drift

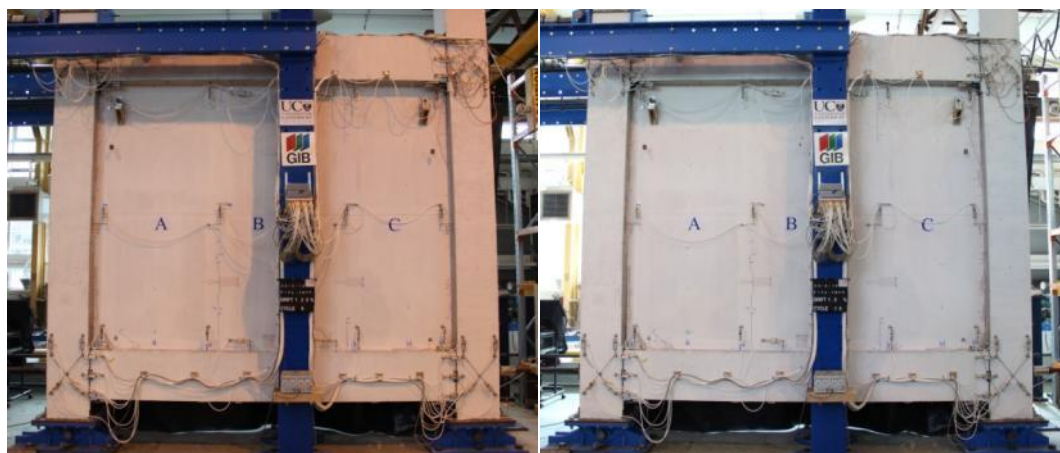
**Figure 0.21.** As built timber framed drywall specimen FIF2-TBFD: a) 1.0% drift, b) 1.25% drift

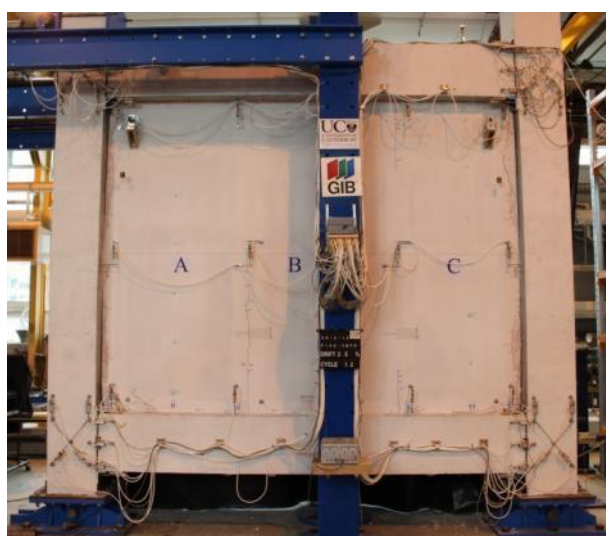
**Figure 0.23.** As built timber framed drywall specimen FIF2-TBFD at 2.5% drift (end of test)

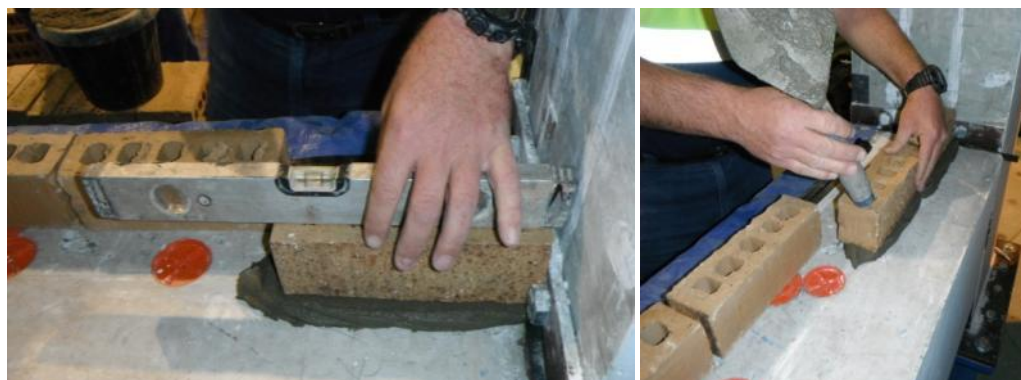
**Figure 0.24.** As built unreinforced clay brick infill wall specimen: Construction of the clay bricks

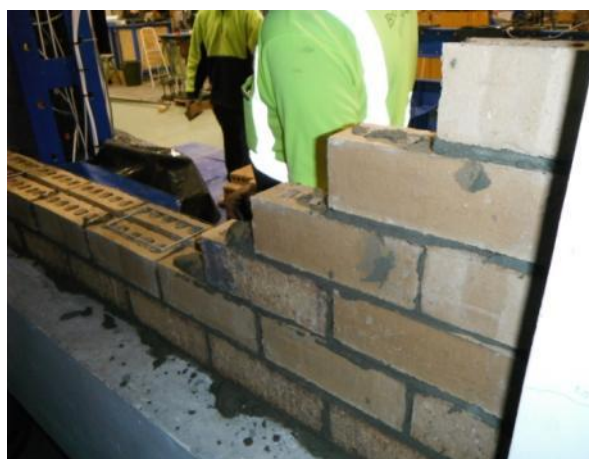
**Figure 0.26.** Four course laid clay bricks at the lower corners of the infill panel zone

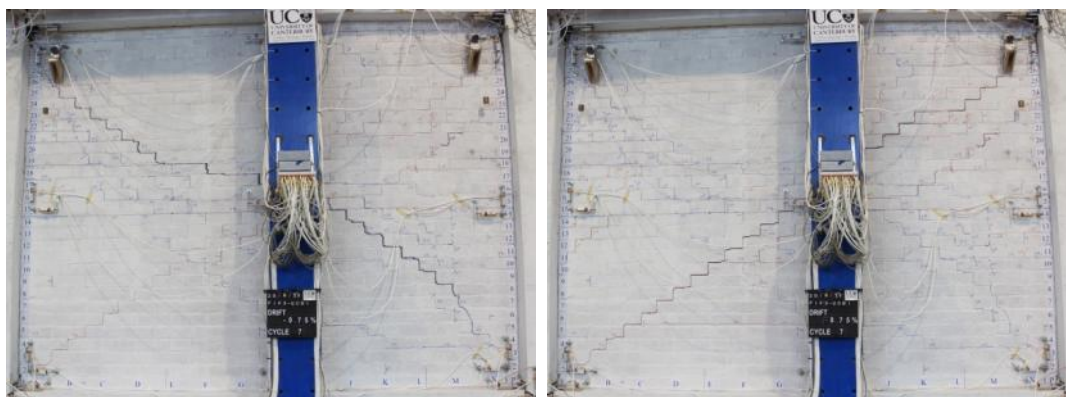
**Figure 0.27.** As built unreinforced clay brick infill wall specimen FIF3-UCBI: a) +0.75% drift (push), b) -0.75% drift (pull)

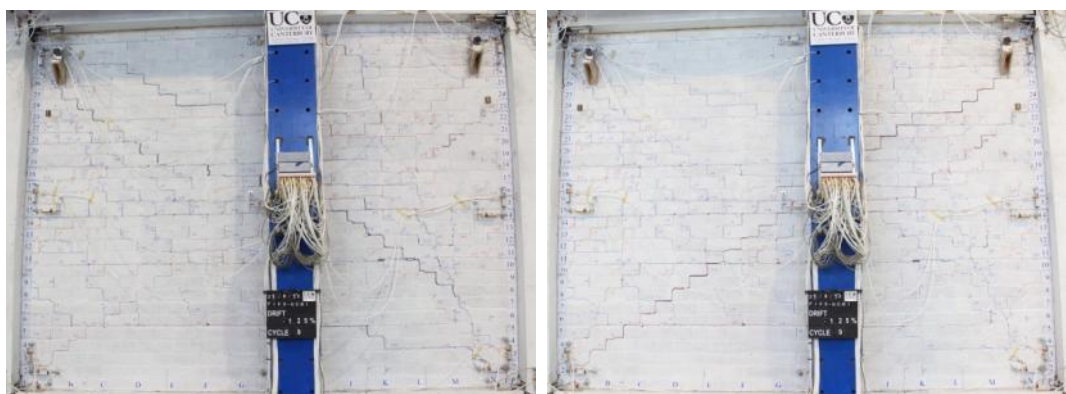
**Figure 0.29.** As built unreinforced clay brick infill wall specimen FIF3-UCBI: a) +1.25% drift (push), b) -1.25% drift (pull)

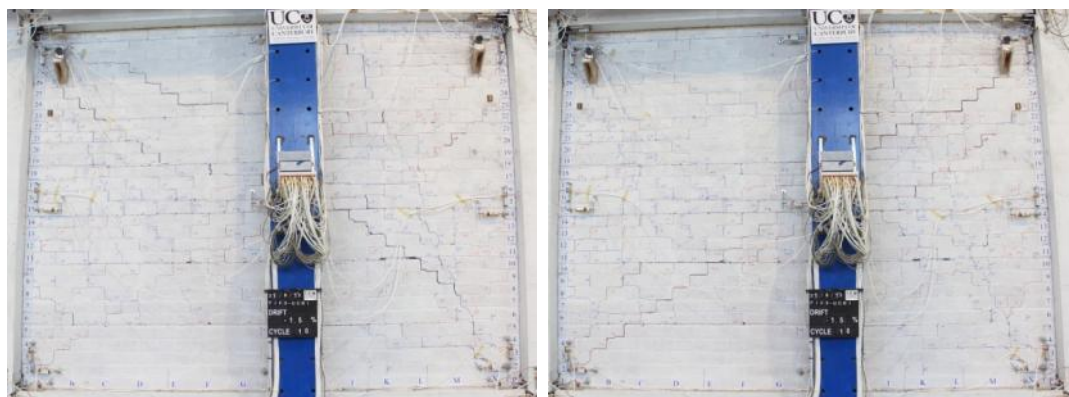
**Figure 0.30.** As built unreinforced clay brick infill wall specimen FIF3-UCBI: a) +1.5% drift (push), b) -1.5% drift (pull)

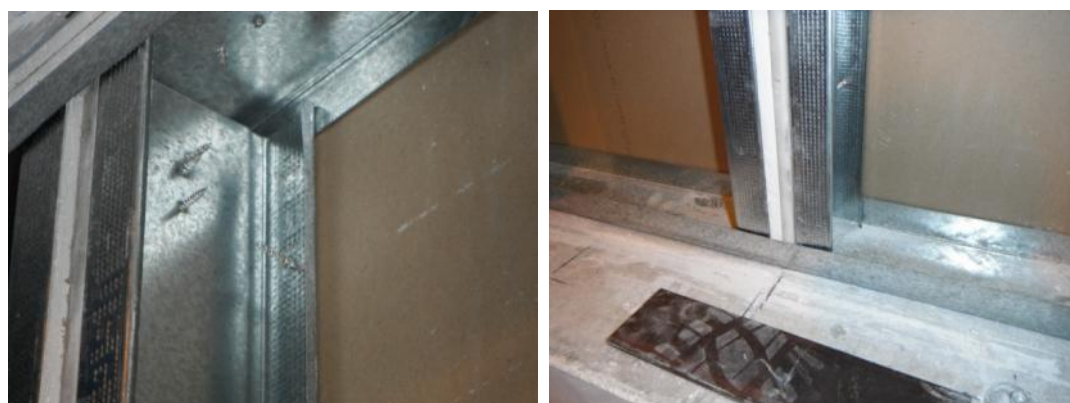
**Figure 0.34.** Low damage steel framed drywall specimen MIF1-STFD: Friction fitted interior fire-rated stud

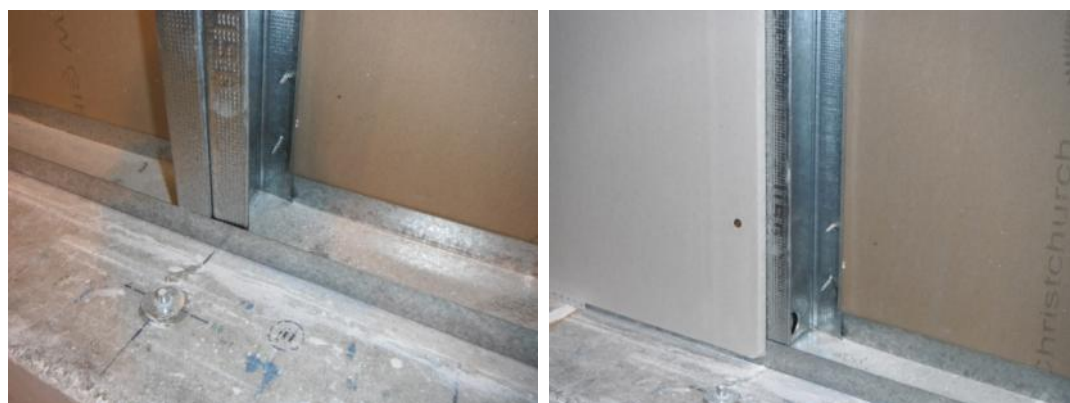
**Figure 0.35.** Low damage steel framed drywall specimen MIF1-STFD: Installation of the gypsum lining to the steel studs (no screw to the steel track)

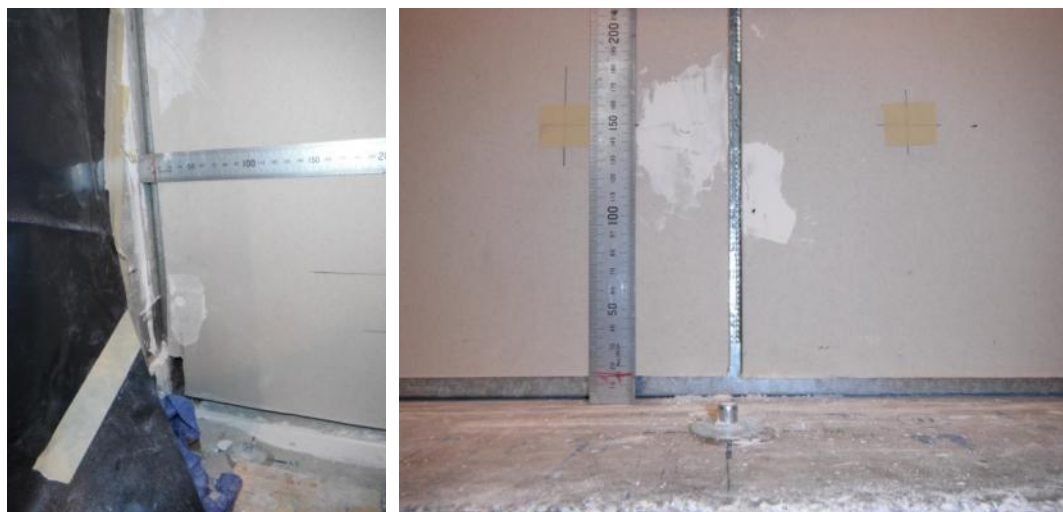
**Figure 0.36.** Low damage steel framed drywall specimen MIF1-STFD: a) Exterior gap of 15 mm at the edge of the gypsum lining, b) Interior gap of 5 mm and bottom gap of 13 mm at the edges of the gypsum linings

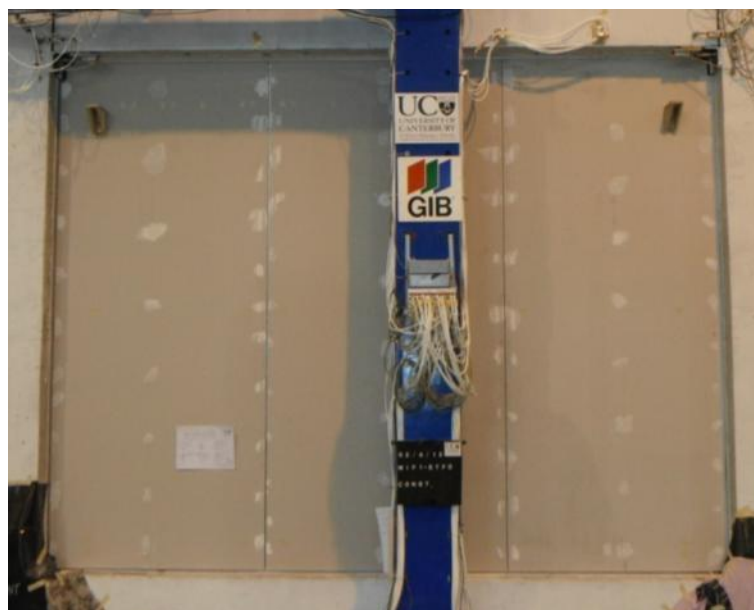
**Figure 0.37.** Finished low damage steel framed drywall specimen MIF1-STFD

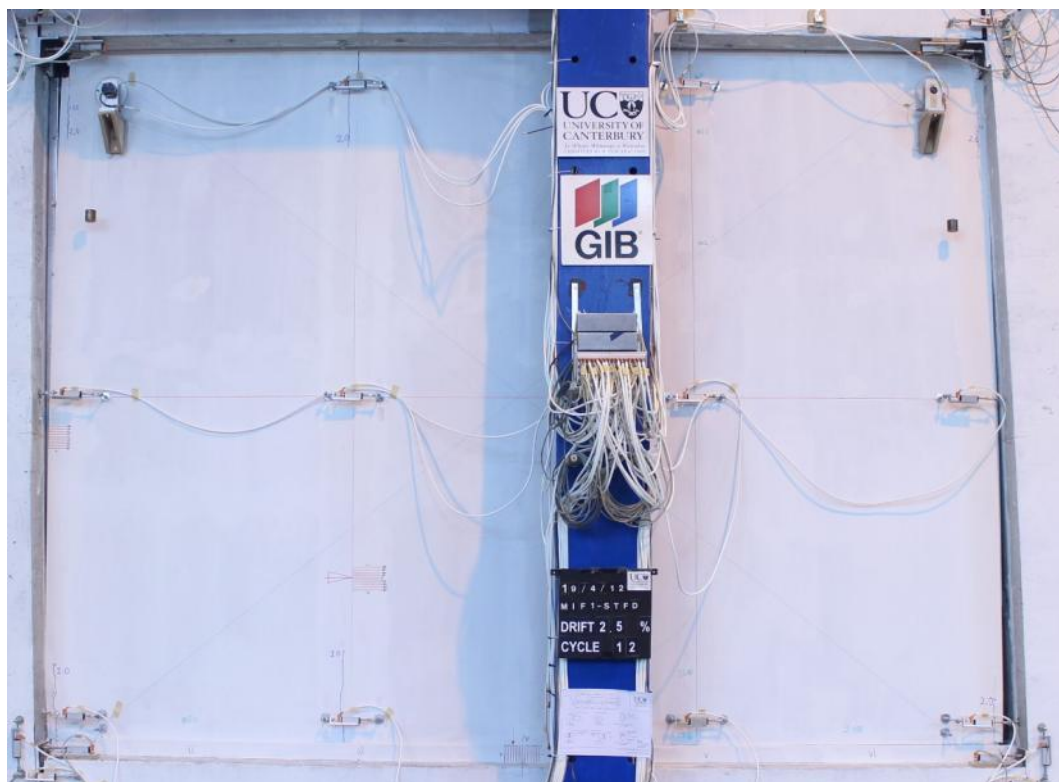
**Figure 0.41.** Low damage steel framed drywall specimen MIF1-STFD at -2.5% drift

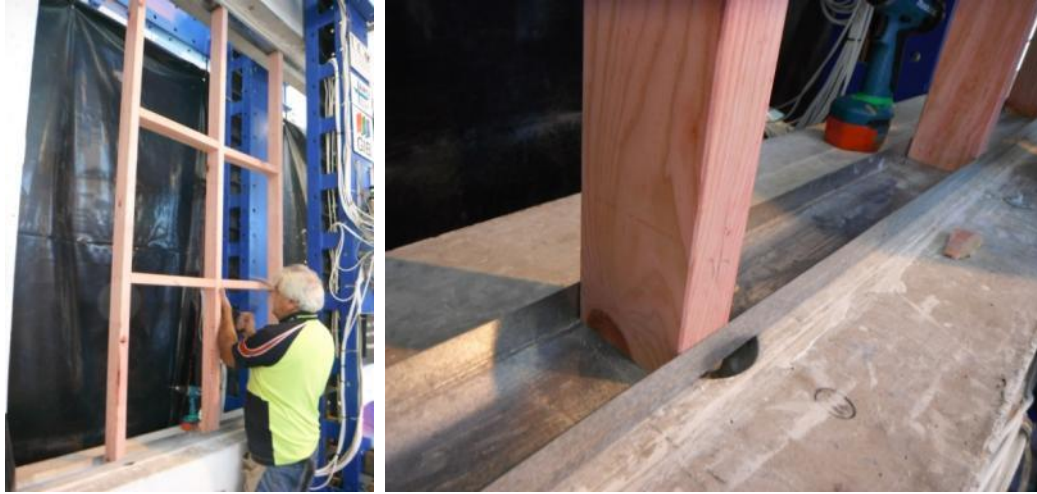
**Figure 0.42.** Low damage timber framed drywall specimen MIF2-TBFD: a) Construction of the timber frame within the steel tracks, b) Friction fitted timber studs into steel channels

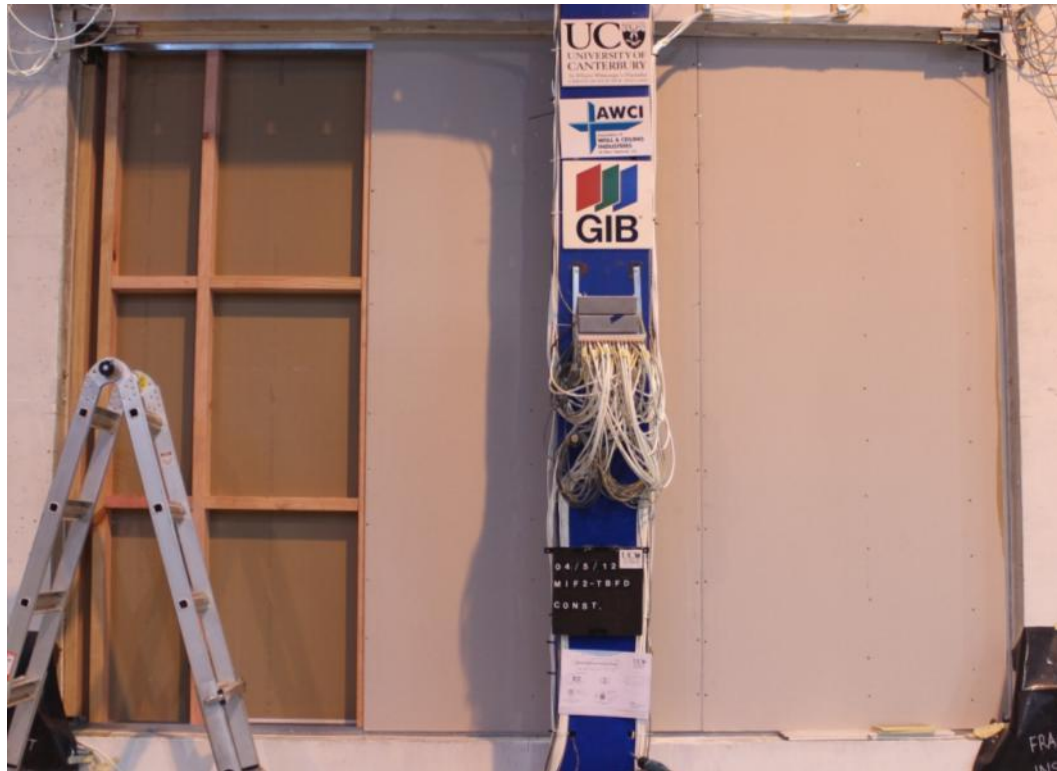
**Figure 0.44.** Low damage timber framed drywall specimen MIF2-TBFD about to be completed

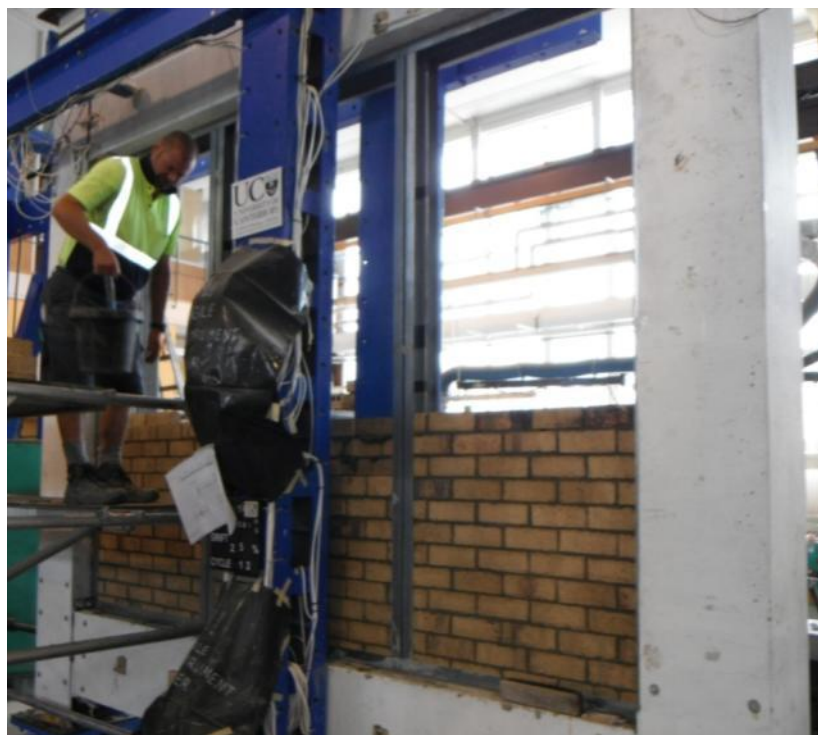
**Figure 0.47.** Construction of the low damage unreinforced clay brick infill wall specimen MIF5-UCBI
